Studebaker

SERVICE BULLETIN

NO. 312

DIVIDED FRONT SEAT LEAN-BACK ALIGNMENT - 1956 MODELS

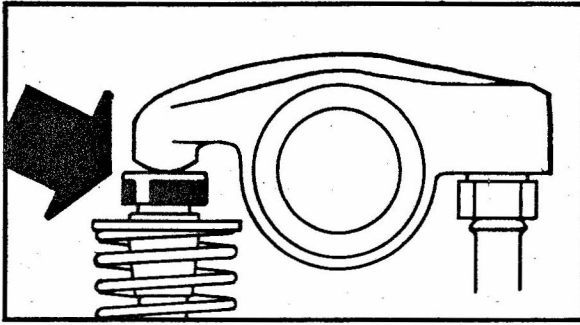
FIG. 1

A special valve stem cap for V8 engines has been made available for service. It may be used in correcting cupped valve stem ends, which result in excessive valve noise and inaccurate settings, without grinding stem ends. It is not necessary to disassemble the rocker assembly to install them. Loosen the rocker arm bracket screws and cylinder head cap screws that hold the rocker assembly to the head, and insert the special valve stem cap. Retighten

the cap screws. Readjust the valve clearances to original specifications.

The valve stem caps should be installed in complete sets. The caps are available from the Parts and Accessories Division through your Parts Depot under Part No. 536426. Sixteen are required per car.

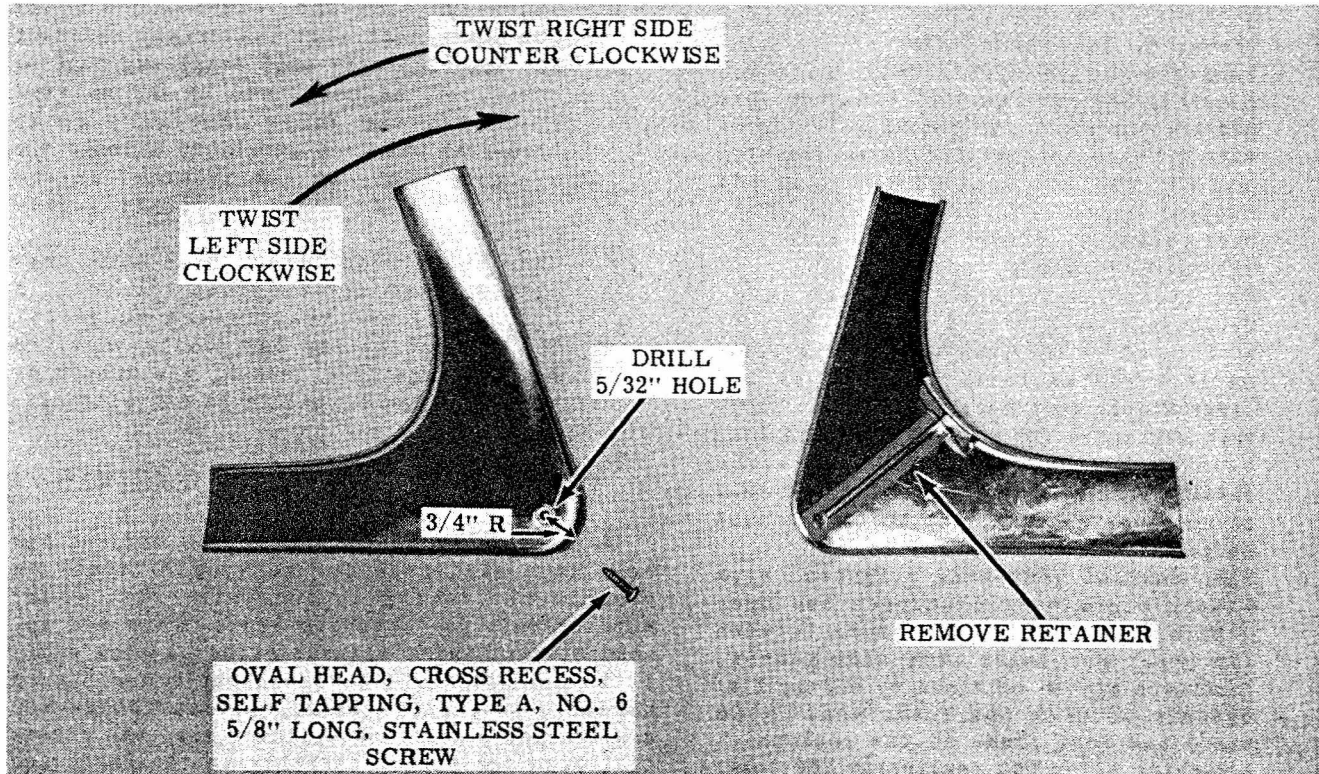
FIG. 2

Commander, and President models have recently been changed to provide an improved fit of the mouldings to the body rear glass weather seal and body contour. The top moulding retainer flange has been relieved by V-shaped notches for better forming during installation. The corner moulding inner retainer has been deleted and a stainless steel screw placed in the forward corner to secure the moulding against the body panel.

Remove the corner moulding retainer section from the weather seal, top and lower mouldings. Remove and discard the retainer from the corner moulding. Twist the upper section of the moulding to obtain approximately 1/2" set. Right side - twist counter-clockwise. Left side - twist clockwise. Locate and drill a hole at the center of a 3/4" radius on the corner moulding as shown (Fig.2) and carefully countersink the hole.

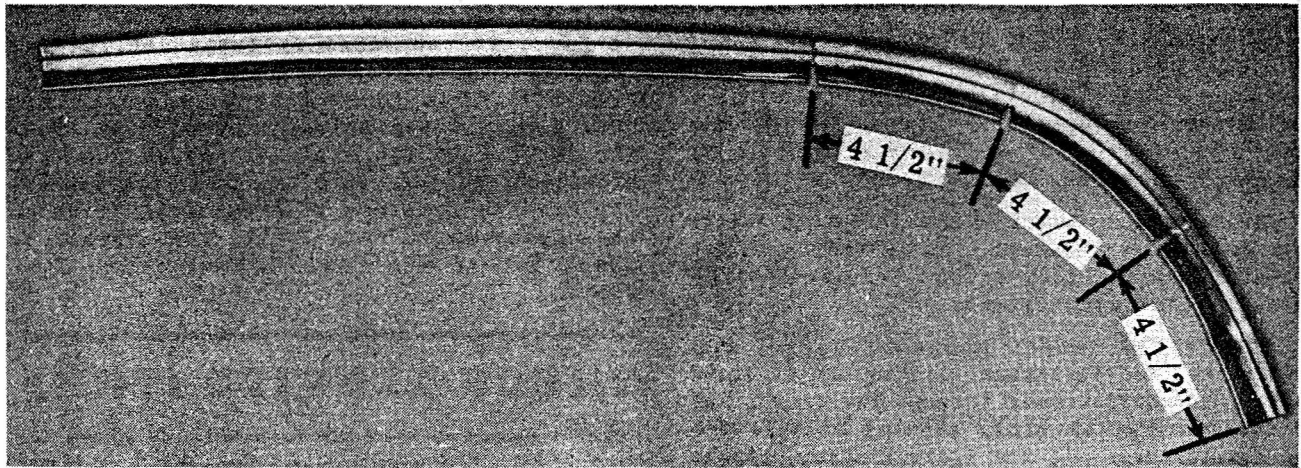
FIG. 3

Should the top moulding not fit satisfactorily, it too may be modified to improve its appearance. Apply liquid soap in the rear body glass weather seal moulding retainer groove and disengage the retainer section. Slide the moulding up and out of the groove. Remove the

Cut three slits as deep as possible, in the top moulding retainer section then cut each side of the slit to form a notch all the way to the bottom of the retainer at 4-1/2" intervals as shown in Fig. 3.

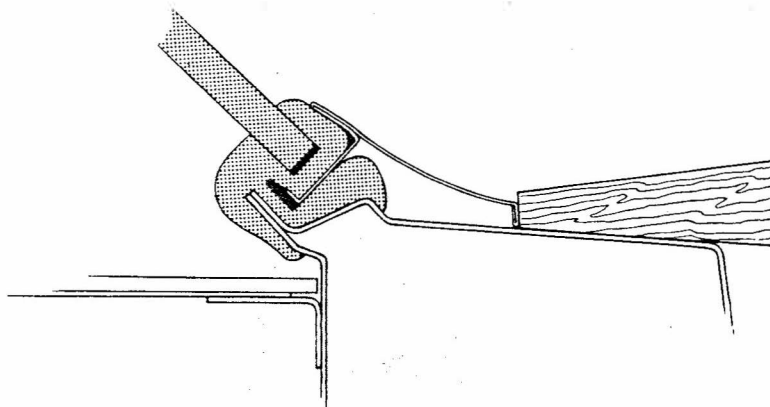
FIG. 4

Where the bottom moulding does not fit down to the deck lid panel, leave the moulding installed in the seal, and holding the moulding firmly against body panel with both hands, one on each side of gap, have a helper use a piece

of fibre or hard wood placed on the lower side of the moulding flange. Move moulding up toward glass by tapping lightly against the fibre or wood block. (See Fig. 4.) Extreme care must be taken not to distort the moulding. (Protect the painted area against damage.)
