SERVICE BULLETIN

NO. 316

1956

ENGINE DETONATION - GOLDEN HAWK 56J MODELS

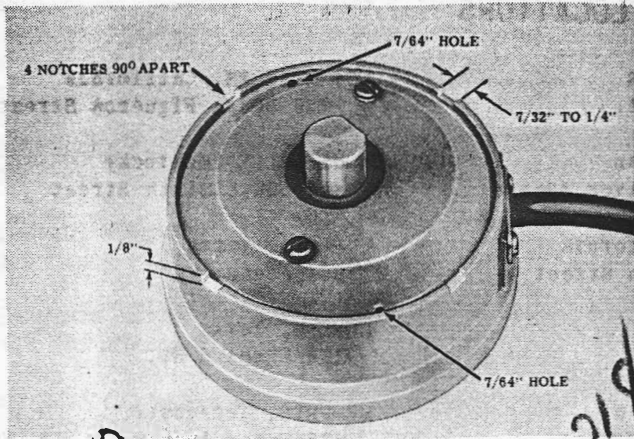
FIG. 1

Certain atmospheric conditions may result in an accumulation of moisture inside the cap and the engine misfires or may not start.

If the inspection reveals the presence of moisture or corrosion, the cap must be carefully cleaned and thoroughly dried. If the center carbon contact and the high tension contacts are badly corroded, the cap should be replaced. Then, to prevent recurrence of the condition, the distributor must be vented.

1. Remove the tachometer drive unit assembly and drill two 7/64" holes through the unit in the groove adjacent to the outer rim. (See Fig. 1).

2. File 1/4" notches in the rim of the unit (See Fig. 1). Install the tachometer drive unit and assemble the rotor and distributor cap and wires.

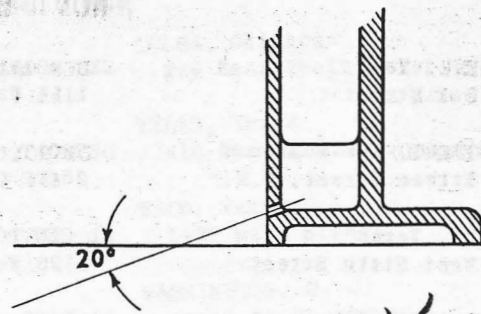
FIG. 3

Under certain conditions raw gasoline accumulates in the carburetor air horn pockets in which the bowl vents are located. A backfire could ignite the gasoline in the pockets and result in severe damage to the carburetor. Therefore, to lessen the possibility of damage to the carburetor if repeated backfiring is encountered, drain holes can be provided to prevent the accumulation of gasoline.

3. Then, with a No. 53 (or 1/16") drill, drill the hole from the inside of the air horn into the pocket at an angle of approximately 20° (see Fig. 3).
4. Make sure all chips are removed and the air horn is clean. Then reassemble and install on the carburetor body.

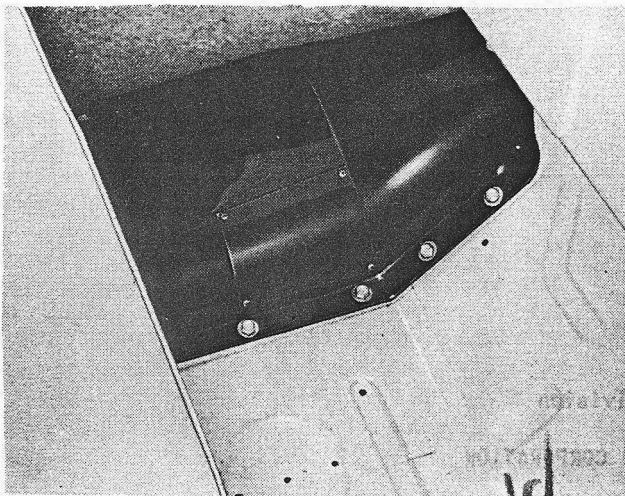
FIG. 4

Effective in production with Serial Nos. E7-7049 and E12-2815 the floor pan cover is provided with a cover plate (see Fig. 4) to permit access to the automatic transmission oil level dipstick.
