Service Bulletin

NO. 320

Studebaker and Packard Clipper

CARBURETOR MODIFICATIONS ON 1957 GOLDEN HAWK 57H-K and 1957 PACKARD 57L MODELS

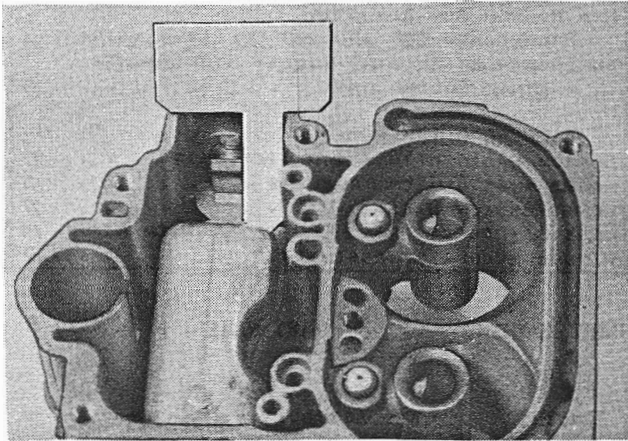
Fig. 1

When the engine is hot, it was found that gasoline foam was being ejected from the bowl vent tube into the air stream. This is caused by the float dropping on a left turn and allowing gas to enter the float chamber under temperatures at which the gas was boiling.

A new Air Horn Gasket, Part No. 1543362 has been designed in which the vent hole in the gasket is not in line with the bowl vent tube, also a Baffle, Part No. 1543363, (see Fig. 1) has been released to be installed in the bowl chamber between the float and float needle valve (see Fig. 2). This baffle restricts the surge of gas from one end of the bowl to the other.

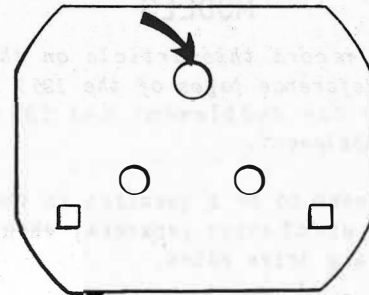
Fig. 3

A 1/4" hole will be placed in the choke butterfly to eliminate the over-rich condition after starting the engine when cold.

A lean condition that exists after starting has been corrected by shortening the choke stove-to-carburetor pipe 1 1/4". The above mentioned 1/4" hole should be drilled in the center of the choke butterfly in the wide side (see Fig. 3) and the choke stove-to-carburetor

pipe shortened 1 1/4".
