Service Bulletin

NO. 322

Studebaker and Packard Clipper

POWER BRAKE UNIT NOISE - 1956-1957 STUDEBAKER AND 1957 PACKARD CLIPPER

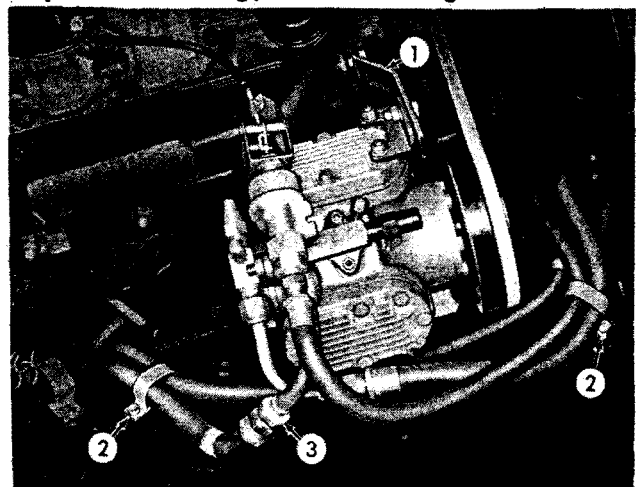
Fig. 1

1. Belt Tension Adjusting Strap
2. Hose Clamps
3. Evaporator-to-Compressor Hose

1. Remove the air cleaner.
2. Remove the compressor belt tension adjustment strap (1, Fig. 1).
3. Remove the four compressor-to-support bracket bolts.
4. Remove the supercharger and compressor drive belts.
5. Remove the screws from the hose clamps (2) on each side of the compressor on the fender apron.
6. Remove the screws from the hose clamps underneath the body along the frame side rail.
7. Pull the evaporator-to-compressor hose (3) forward to take out the slack and move the compressor assembly forward into the corner of the fender far enough to clear the valve cover.
8. Remove the valve cover and adjust the valve clearances in the usual manner. Note that the generator is left in position to drive the water pump and fan.
9. After completion of the adjustment, re-assemble the right side completely including the adjustment of the compressor and supercharger drive belts.

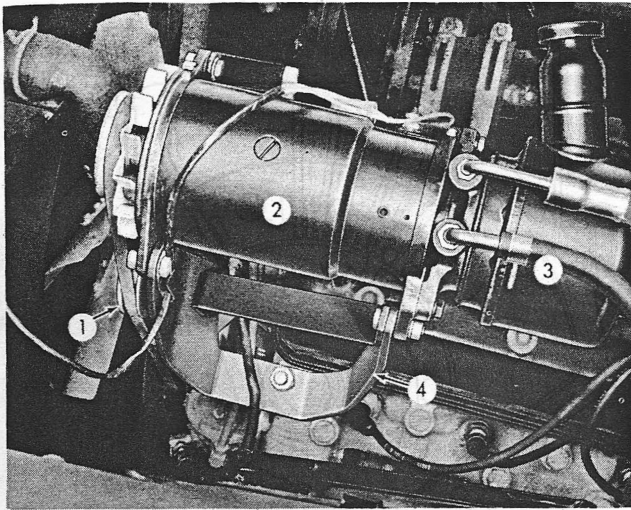
Fig. 2 G-228

1. Generator Drive Belt Idler Pulley
2. Generator
3. Power Steering Pump
4. Generator Support Bracket

power steering pump as an assembly. (See Fig. 2). Remove the generator support bracket and idler pulley as an assembly.

3. Place the belt out of the way so that it will stay clear of the pulleys. Note - The compressor belt will drive the water pump and fan.
4. Remove the valve cover and adjust the valve clearances in the usual manner.
5. After completing the adjustments; install the generator support bracket and pulley assembly, generator (or generator and pump assembly if equipped with power steering) and generator drive belt. Do not roll the belt on the pulley. Adjust the tension of the generator drive belt.

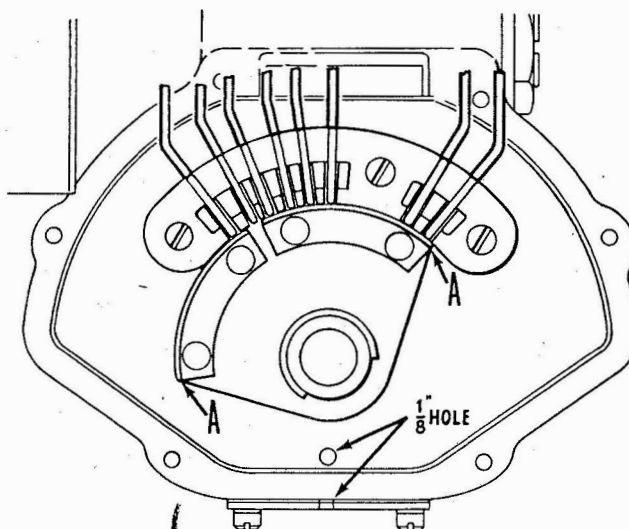
Under certain conditions condensation may accumulate in the actuator unit of push button control and cause corrosion of the contacts; also, an accumulation of transmission oil in the unit, if leakage occurs at the manual valve lever shaft seal.

When the contact segment of the actuator unit is permitted to overtravel by malfunctioning of some member or circuit in the control system damage may be caused to the contact fingers on the finger and lead assembly. This is particularly true of the early production units.

The contact segment may have a sharp edge at each corner. When the unit is permitted to overtravel, on the return, the sharp edge may dig into the contact finger which will make the unit inoperative and usually create severe

arcing when the control buttons are pushed or operated for a change of position.

To provide ventilation so that condensation is held to a minimum and in the event of a leak at the seal so that the oil may drain, we suggest that you make the following modification.

Drill a 1/8" hole at the center lower inner edge of the base plate to provide a vent into the lower main housing and another 1/8" hole in the inspection plate and gasket to provide a vent and drain from the main housing. Fig. 3 illustrates the approximate locations of the holes.

This modification will also reduce the tendency of the transmission oil to seep past the seal. Therefore, it is recommended if the actuator is removed for any reason that the modification be made. Obviously, if a condition of oil in the actuator is encountered, also replace the seal.

To prevent this interference when an overtravel occurs, round-off or chamfer the two corners (A, Fig. 3) of the contact segment.

This should be done when the segment is removed for any reason and the unit involved has sharp edges.
