# Service Bulletin

NO. 325

SOUTH BEND 27, INDIANA

## Studebaker and Packard Clipper

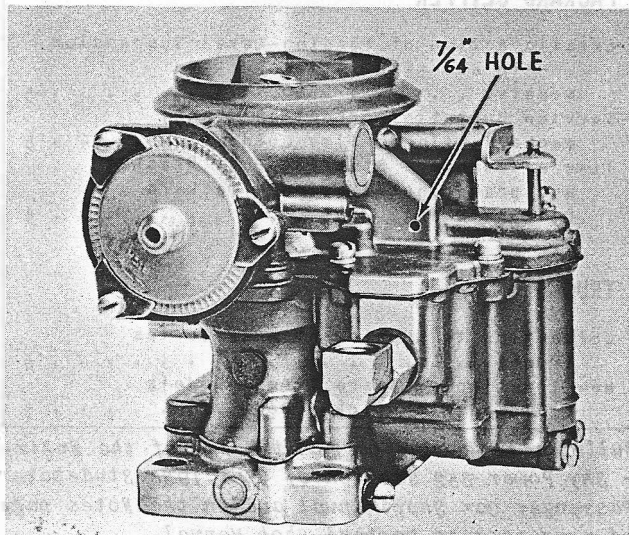
Fig. 1

On a complaint of hard starting or prolonged cranking to start a hot engine on models equipped with a supercharger, modifying the carburetor and air chamber cover as outlined below will provide considerable improvement.

1. Remove the carburetor air chamber cover and remove the carburetor from the engine.
2. Drill a  $7/64$ " hole into the vent passage at the location shown in Fig. 1. Then, drill two  $5/64$ " holes in the throttle body at the locations shown in Fig. 2. It is not necessary to disassemble the carburetor to drill the holes but care should be taken to prevent chips from entering the carburetor.
3. If the air chamber cover does not have a

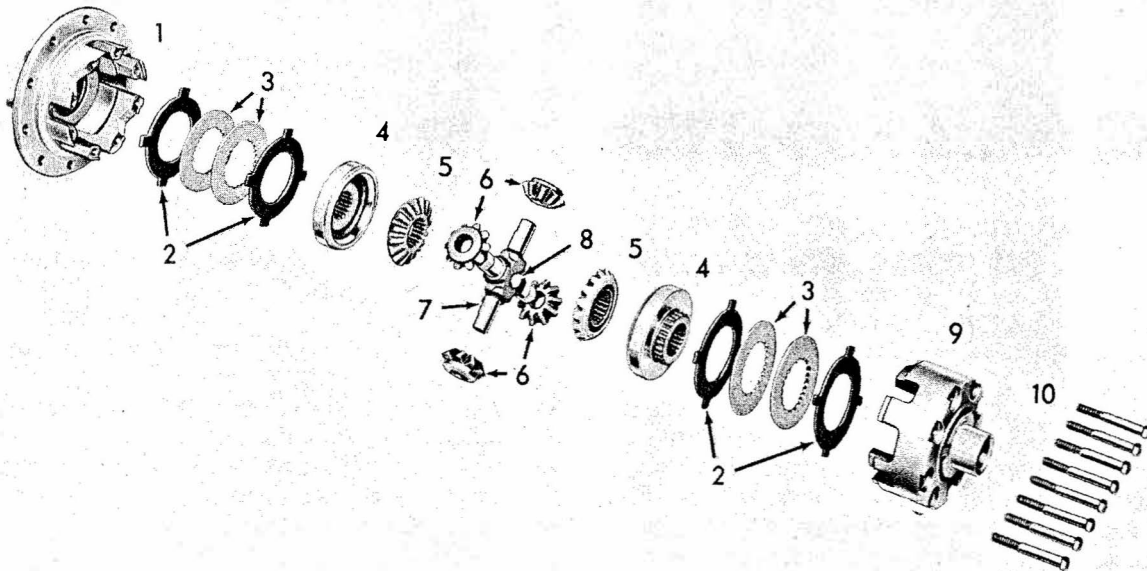
A change has been made in the Twin-Traction differential; the cone-type clutches have been replaced by disc-type clutches. Fig. 5 illustrates the exploded view of the latest type.

The disassembly and reassembly procedure with the exception of the clutches is the same for both types. When reassembling the disc type, the lugs of the plates are placed in the notches provided in the housing. Note the relationship of the discs to the plates; the two friction discs are placed between the plates.

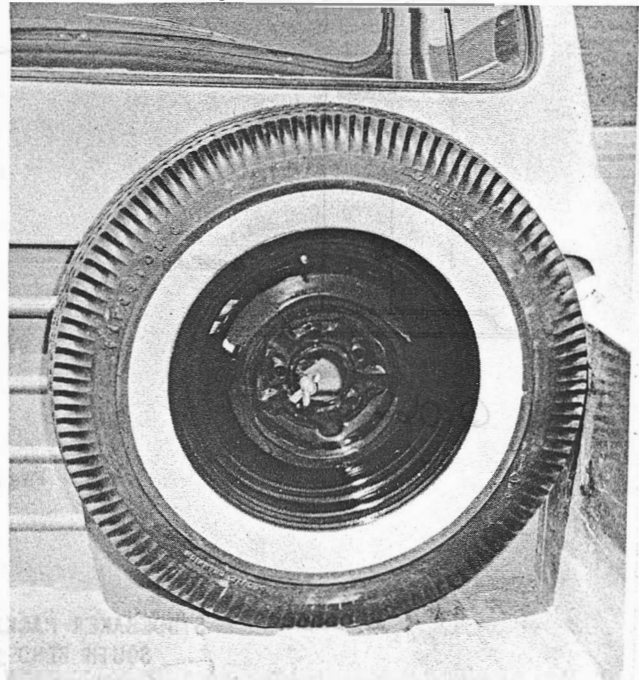
Fig. 7

Recently a new location for the spare tire was released as a factory installed option for trucks equipped with a pickup body. At the optional location, the tire is mounted at the front wall of the body (see Fig. 7). This can very readily be adapted to prior models for owners desiring this "in the box" location.
