# Service Bulletin

NO. 338

SOUTH BEND 27, INDIANA

### FRONT SEAT CUSHION SPRING MODIFICATION AND RELOCATION OF COVER TO ELIMINATE CUSHION COVER DAMAGE - 1958 2-DOOR MODELS

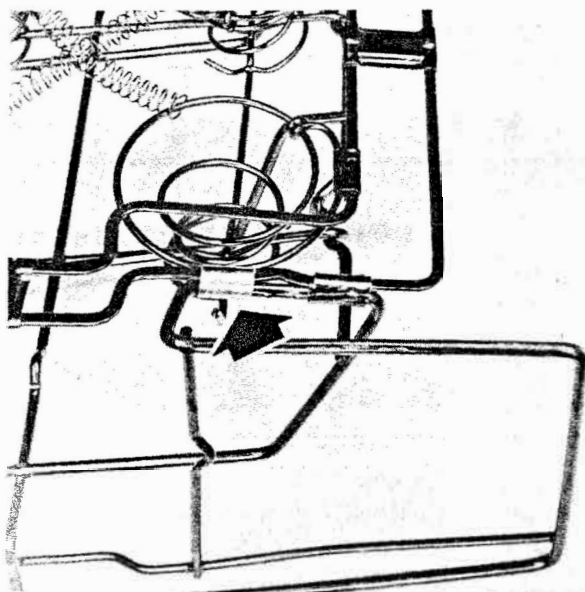
The installation of a second clip (see Fig. 1) on each side of the cushion spring assembly and relocation of the cushion padding as shown in Fig. 2 will eliminate the possibility of cushion cover damage in the clip area. This change entered production with the following serial numbers:

When the clip loosens, the spring assembly top rim and skirt wires separate and cause additional pressure on the cushion cover which may result in damage. Should evidence of this condition appear, on the vehicles manufactured prior to the above serial numbers, immediate action should be taken to fabricate and install a second clip and relocate the padding as described.

The clip may be made from a piece of stock .045" - .050" thick, 5/8" wide and 1 1/2" long.

Remove the hog rings from the cushion cover and uncover the spring assembly as shown or as required.

Place the flat side of the top rim wire directly on top of the skirt wire as shown on Fig. 1 then install the fabricated clip securely.

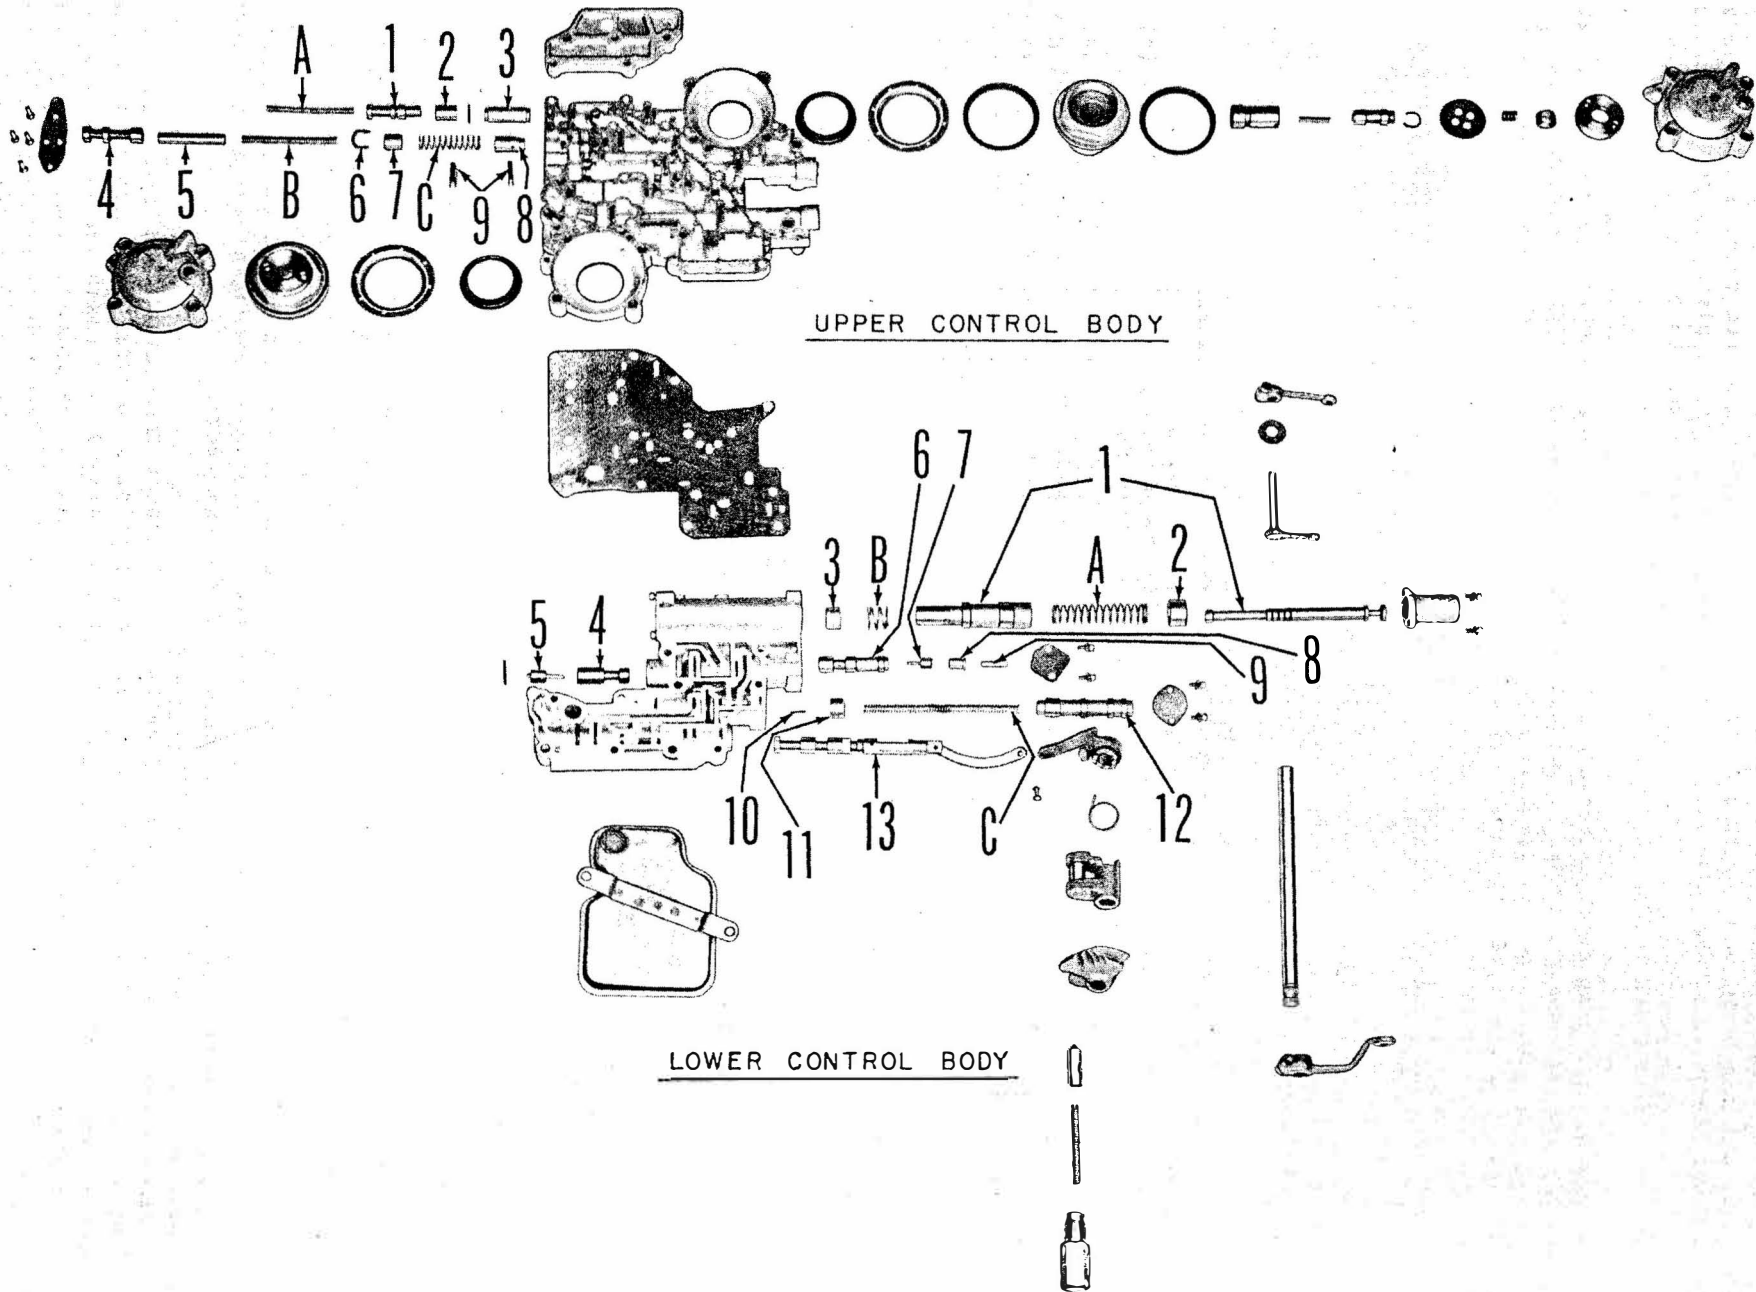
The Valve Control Assembly illustrated in Fig. 3 is Part No. 423800 and is the standard control unit as used in the 1954 Ultramatic prior to gear start. It is supplied for service as a complete assembly replacement for all Ultramatic Transmissions of the 23rd Series after transmission No. 101509, Model 2301 and transmission No. 5360, Models 2302-06, and all 24th Series through the 54th.
