# Service Bulletin

JULY 1958 NO. 339

## Studebaker and Packard

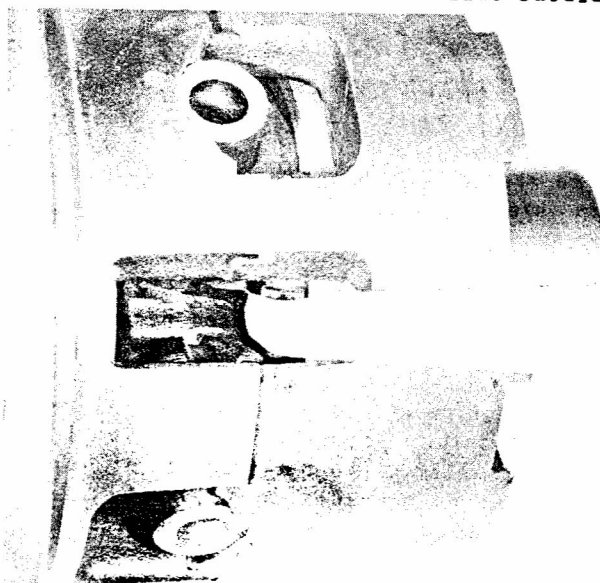
Fig. 1

When removing an axle shaft, one end of the shaft thrust pin may be pulled out of position and the roll pin which retains the two parts of the thrust pin may drop out. This is usually not discovered until you attempt to reinstall the shaft; because the thrust pin is out of position, it will not permit the full installation of the shaft. This, of course, makes it necessary to tear-down the axle and replace the thrust pin and retaining roll pin.

1. Drain the rear axle differential case.
2. Remove the differential case cover.
3. Using a modified hacksaw blade as shown in Figs. 1, 2 and 3, insert the hacksaw blade between the pinion mate shaft and the differential side gear. The hacksaw blade should be

positioned so that it bears against the thrust pin with the saw teeth forward.

4. Pressure should be maintained against the hacksaw blade and thrust pin while the rear axle shaft is removed. The hacksaw blade should be placed between the pinion mate shaft and right hand differential side gear while removing the right side axle shaft and between the pinion mate shaft and left hand differential side gear while removing the left side axle shaft.

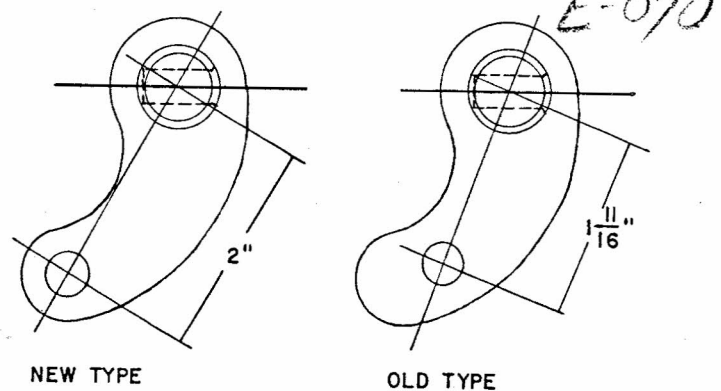
Fig. 4

Under certain circumstances it is possible some gear clashing may occur even though the clutch pedal free travel is properly adjusted. Where this condition occurs it is recommended that Clutch Operating Shaft and Lever Assembly, Part No. 1546329, be installed.

This shaft and lever assembly has a lever radius of 2" instead of 1 11/16" radius originally installed and provides a greater release area for the clutch driven plate (See Fig. 4)

Effective with Serial No. G-1428648 the clutch operating shaft and lever assembly with the 2" lever radius entered production.
