Service Bulletin

NO. 340

Studebaker and Packard

SPEEDOMETER CORRECTIVE SERVICE

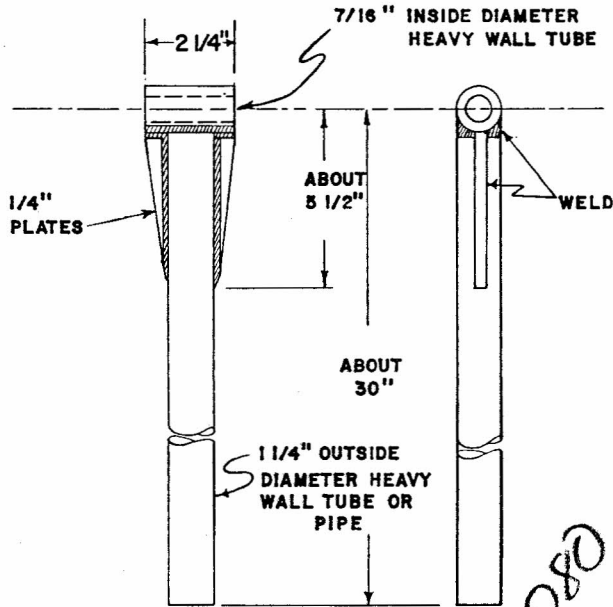
Fig. 1

With reference to alignment of the rear shock absorbers and bushing replacement as covered by the articles in Service Bulletin Nos. 336 and 338, Figure 1 provides a sketch of a suggested tool that may be easily fabricated for bending the rear frame cross member when such procedure is required to obtain satisfactory rear shock absorber alignment.

REAR SHOCK ABSORBER FRAME CROSS-MEMBER BENDING BAR

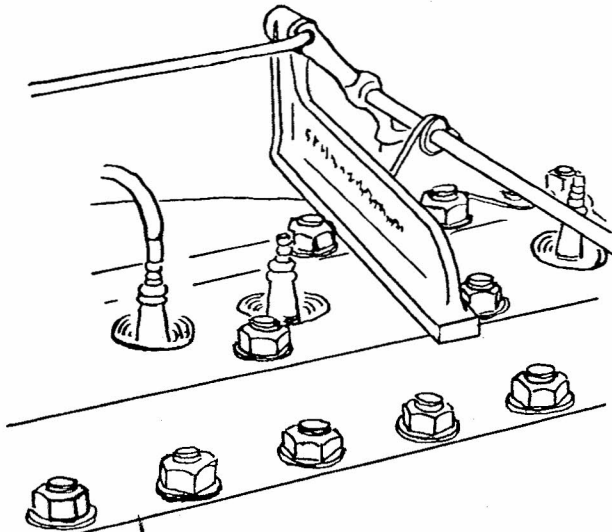
Fig. 4

When the carburetor throttle rod is properly adjusted, the end of the short bend at the rear of the rod will protrude through the hole in the cross shaft lever and enter the hole in the gauge, PK-364. See Fig. 4.

The rod can be lengthened or shortened by loosening the lock nut and turning the spring-loaded throttle over-ride.

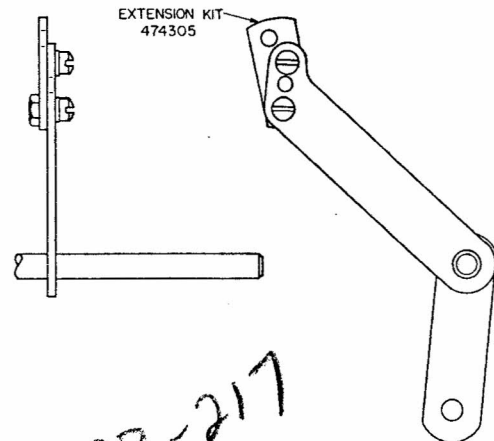
Fig. 7

Unexpected or unwanted kickdown into low range converter range when driving at full throttle or near full throttle position may be encountered in some 55th Series Twin-Ultramatic Transmissions.

Because of the stack-up of tolerances in the throttle linkage and adjustments, the throttle valve kickdown position is being reached before the carburetor throttle valves are fully open.

To take care of the slight variations, the linkage geometry can be changed by installing an extension on the throttle control cross shaft lever as shown in Fig. 7.

After installing the extension, readjust all of the linkage as described on pages 52 and 53 in the Twin-Ultramatic section of your 1955-56 Service Manual. Under 'Adjusting Accelerator Linkage - 55th-56th Series' in this article is described an easy method for checking and setting the linkage in the engine compartment.

Part No. 474305, Carburetor Control Cross Shaft Lever Extension Kit is available from your Parts Depot.

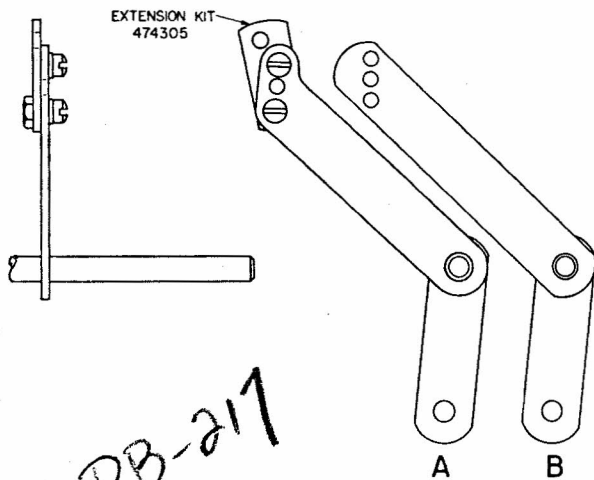
Fig. 8

Some early 56th Series cars had the 55th Series throttle lever 'A' as shown in Fig. 8. Some of these may be equipped with Extension Kit, Part No. 474305; depending on unwanted kickdown or too-easy-a-squeeze-out with wide open throttle.

All 56th Series cars having the throttle lever as indicated by 'B' in the illustration do not require the extension.

If unwanted kickdown or squeeze-out is encountered on 56th Series cars equipped with 55th Series lever, install the Extension Kit 474305 and readjust the linkage as per the Service Manual.
