# Service Bulletin

MARCH

1959

NO. 345

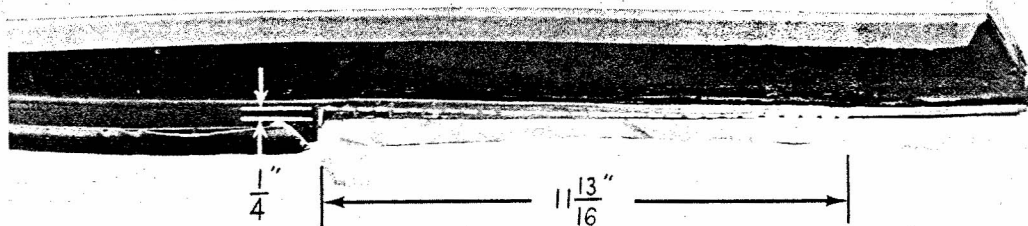
FIG. 1

There have been reports of rattles caused by excessive side movement of the rear quarter windows on Lark Hardtop models when the window is in the full down or open position.

To correct the condition, it is necessary to bring the inner and outer window weather seals closer together to stabilize the quarter glass assembly when it is fully lowered. The following steps will effect a suitable improvement.

1. Remove the rear seat cushion and seat back. Remove the rear quarter trim retainer and peel back the vinyl trim. Measure in 1/4" from the offset in the retainer and mark, then toward the rear of the retainer from the 1/4" mark, measure 11-13/16" and place a mark at edge of the metal. Scribe lines to the marks, see Fig. 1.

With a hack saw, cut on the lines scribed on the metal and remove the marked section.

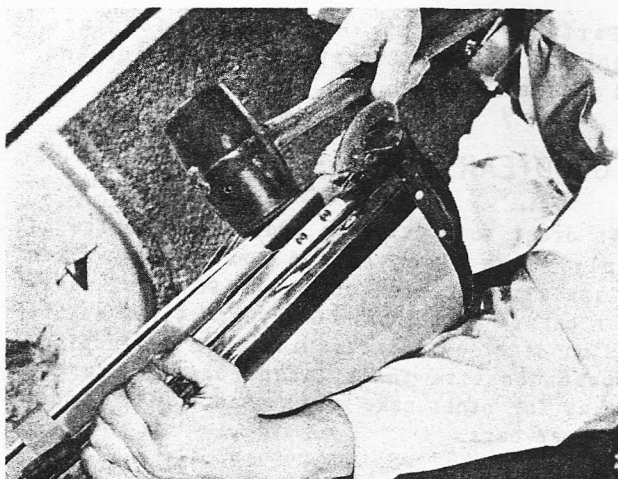
FIG. 5

**CAUTION:** If the inner panel is moved in too far, the trim panel when installed will cause a binding of the rear quarter glass when the glass is raised to a full closed position.

body, bump the inner panel toward the outside, using a rubber or wood mallet, see Fig. 5. In most cases only two or three sharp blows will be required.

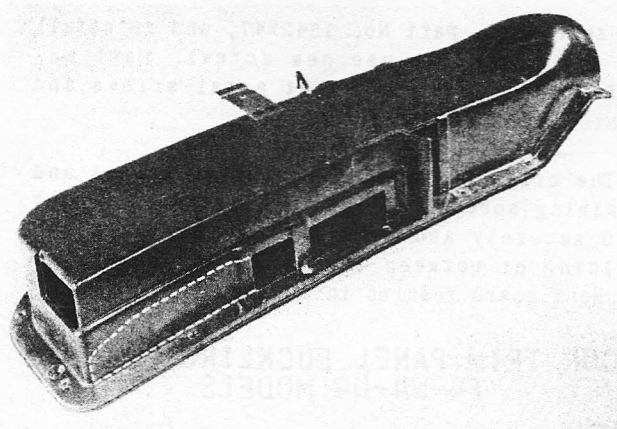
FIG. 6

To direct more warm air to the driver's feet, a change has been made in the Climatizer air distribution duct.

1. Remove the attaching screws, disconnect the valve control cable and disconnect the defroster noses from the top of the air duct.
2. Pull the air distribution duct away from the blower and remove the air duct from the dash.
3. Scribe the bottom surface of the duct, as shown by the dotted lines on Figure 6.

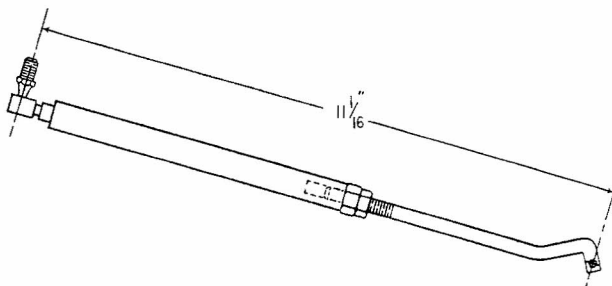
FIG. 8

In order to obtain proper throttle valve linkage relationship in a Lark VI Model equipped with a Flightomatic transmission, the throttle valve linkage adjustment procedure in the 1959 Shop Manual, Group IV, Page 39, should be supplemented with the following information:

As step 1 for performing the carburetor-to-transmission throttle valve linkage adjustment, the throttle control bellcrank-to-carburetor rod assembly (see Fig. 8) should be checked and adjusted to provide 11-1/16" between the centerline of the ball stud and centerline of the cotter pin hole. After adjusting the carburetor rod assembly to this length, it should not be altered during any subsequent adjustment operation.
