Service Bulletin

JUNE

1959

NO. 348

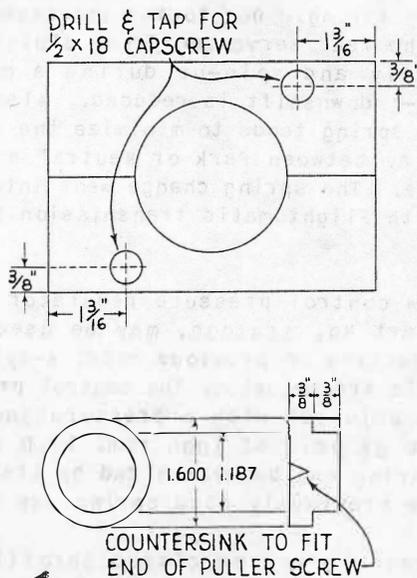
The Pinion Rear Bearing Remover J-5365 can be modified so that it can be used as a differential side bearing remover.

Drill and tap the Remover tool for a 1/2"-18 thread at the locations shown in Fig. 1.

To remove the side bearing, install the Remover tool on the side bearing. Place a centering or adapter plug in the end opening of the differential. If a suitable adapter plug is not available, one can be made to the dimensions shown in Fig. 1

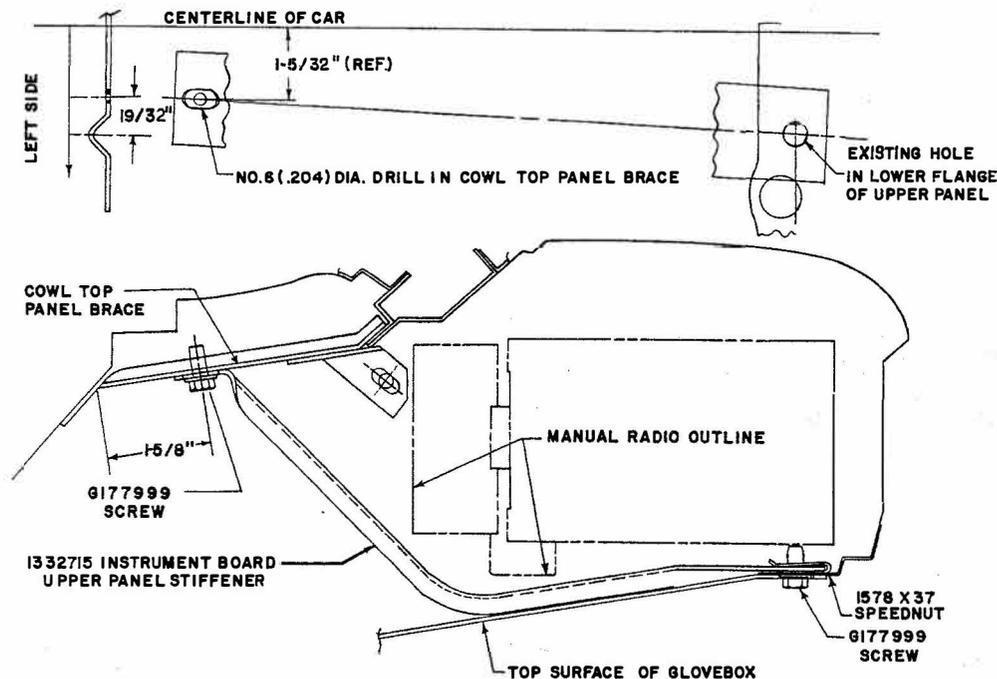
Fig. 3

To provide increased stability of the instrument board panel, a stiffener brace entered production starting with Serial Nos. 59S-80105 and 59V-30318.

The brace, installed as shown in Fig. 3, may easily be installed in cars before the above serial numbers. The brace will reduce instrument board movement and assist in preventing squeaks, buzzes and rattles caused by excessive instrument board movement.

To install, first remove the glove compartment box. It is not necessary to remove the radio in cars so equipped. Place the flat end of the brace on the upper opening flange for the glove box at the first hole to the left of the door catch and install the Screw, Part No. G177999, and Speednut, Part No. 1578X37. Using the brace as a template or the dimensions given in Fig. 3, mark and drill a 3/16" hole in the cowl top panel brace and install Screw, Part No. G177999. Install the glove compartment box.

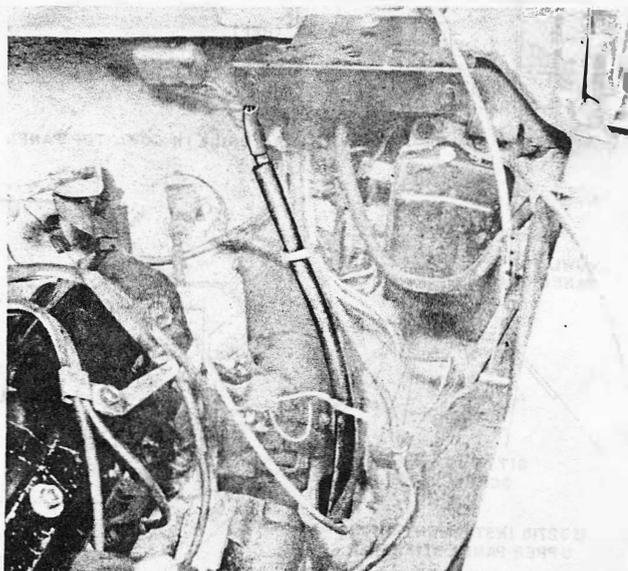
FIG. 4

To prevent possible interference between the starter motor cable and the accelerator linkage, the starter switch-to-starter motor cable has been lengthened and rerouted on 59V Lark Models. This change entered production with Serial No. 59V-26047.

Note cable routed through
body hold-down bracket

The improved routing of the cable is shown in Figure 4, 5 and 6.

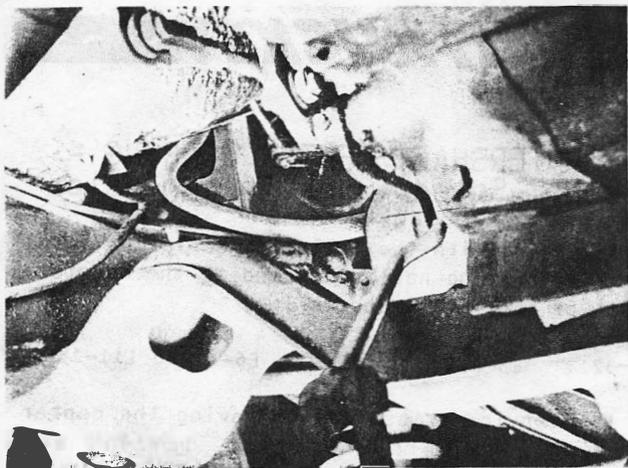
Fig. 5 - Car with OD and Power Steering. Clutch Operating Shaft removed to show cable.

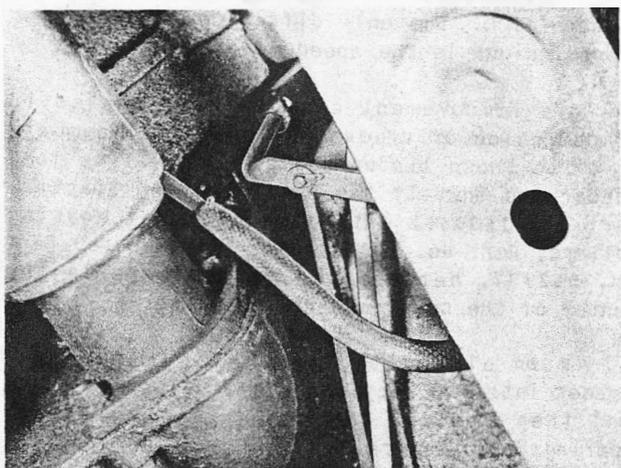
Fig. 6 - Car with Automatic - Note position of Cable in respect to throttle linkage.

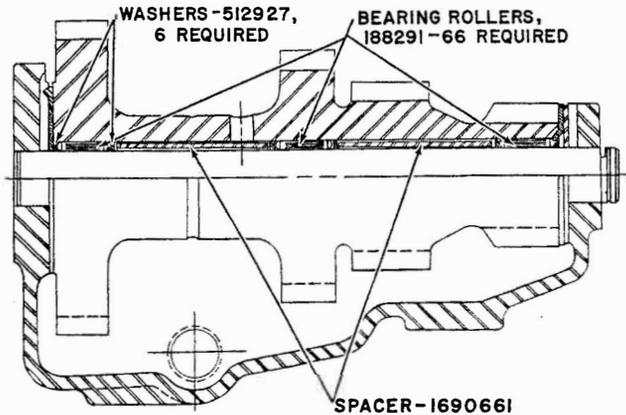
FIG. 7

Beginning with the following serial numbers, a center bearing has been added to the countershaft of the T90B transmission.

This improvement can be incorporated in transmission of trucks having serial numbers prior to those listed above. Remove the long spacer and install two short Bearing Spacers, Part No. 1690661 with 22 additional bearing rollers, Part No. 188291, and two washers, Part No. 512927, between the two spacers in the center of the countershaft. See Fig. 7.

As an alternate, you may cut the long spacer into two sections 2.079" (2-5/64") long and then install the necessary additional bearings and washers.
