# Service Bulletin

AUGUST

1959

NO. 349

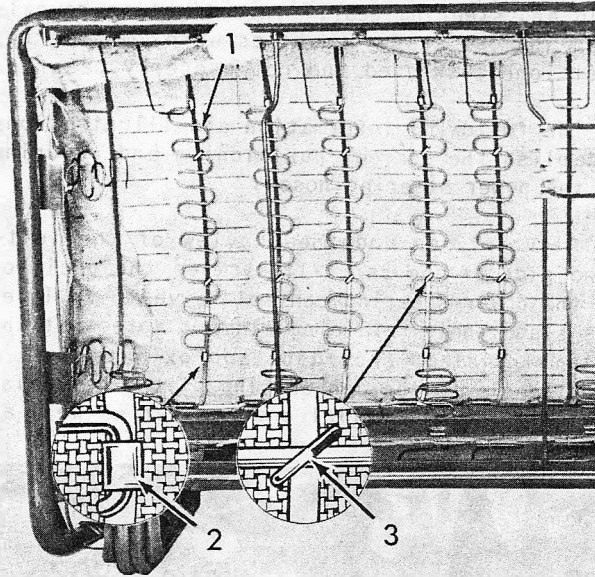
FIG. 1

Some seat cushion and seat back sagging has occurred on 1959 cars; especially on taxicab and severe service vehicles. To correct this sagging condition a Front Seat Cushion or Back Heavy Duty Kit AC-2986 (Part No. 1333999) has been released for service. This kit consists of Reinforcing Elements, Part No. 1333896, Clips, Part No. 1333553, and instructions for installing the elements in the seat cushion and seat back. See Fig. 1

One AC-2986 kit will service one front seat divided back or 1/2 of a solid seat back. In order to service both sides of a solid seat back, or both divided front seat backs it will be necessary to order two AC-2986 kits.

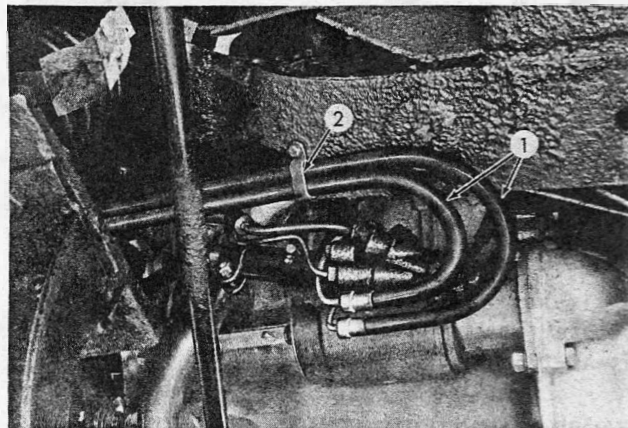
FIG. 2

We have received reports of power steering hoses coming in contact with the exhaust manifold and steering gear. Investigation reveals that in most cases the hoses were improperly positioned, twisted and not properly secured.

Figure 2, an underneath view of the left-hand side of the car, illustrates the position of the power steering control valve-to-cylinder hoses and their retaining clamp. Note that the retaining clamp should be approximately at a right angle to the center line of the car, also that the hoses parallel one another as well as the frame.

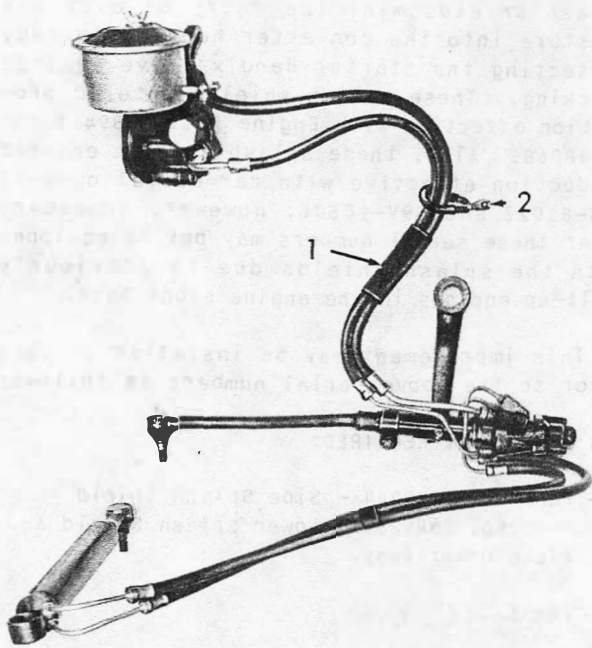
FIG. 3

The relative position of the power steering pump, control valve assembly, pitman arm and reach rod, and the power steering cylinder are shown in Fig. 3. This illustration reproduces, as closely as possible, the relative positioning of these units and hose assemblies in their installed positions. The protective grommet on the power steering pump-to-control valve hoses should be located approximately 7" from the lower end of the hoses. This is necessary to prevent any scuffing of the hoses by the steering gear housing. The spring wire and sleeve assembly must be wrapped around the two pump-to-control valve hoses approximately 3" above the protective grommet, with both ends of the spring secured to the retainer clip

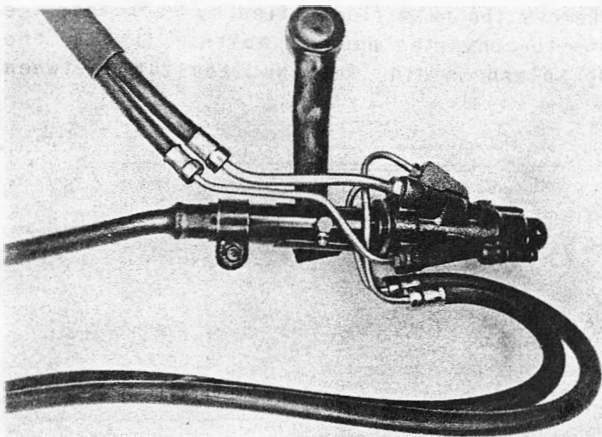
FIG. 4

A close-up side view of the control valve assembly, (see Fig. 4), shows the correct positioning of the hose and tube assemblies. Note that the control valve-to-power steering cylinder hoses are parallel and should be secured by the frame clip (see Fig. 2) so that the hoses do not droop downward at the looped portion of the hoses.

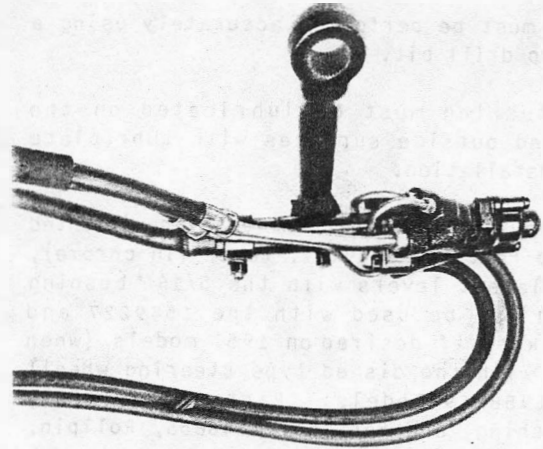
FIG. 5

The top view shown in Fig. 5, illustrates the correct position of the power steering pump-to-control valve hose and tube assemblies, and the control valve-to-cylinder hose and tube assemblies.

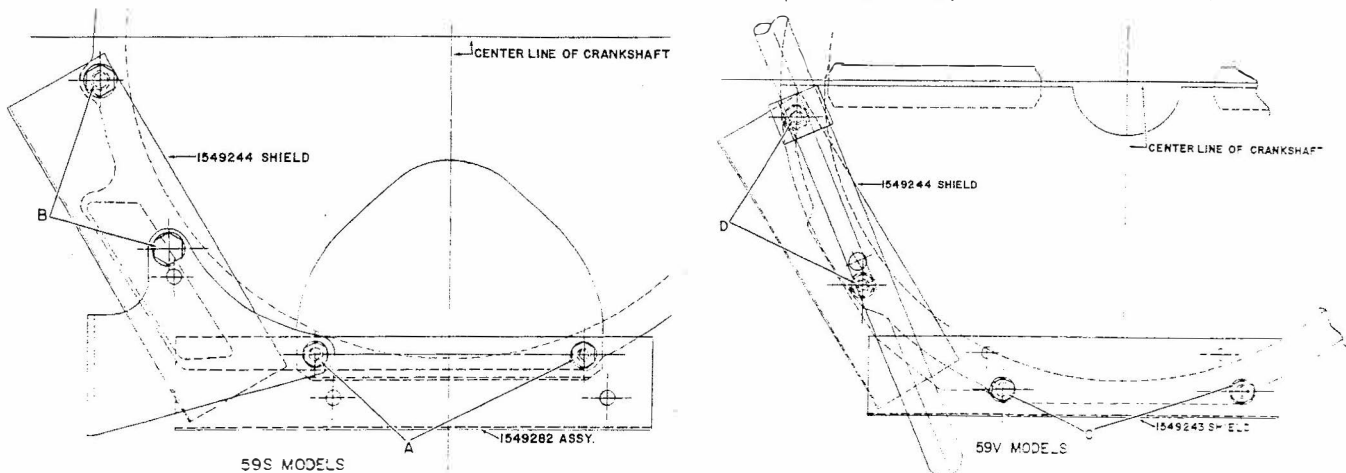
FIG. 6

Two new splash shields have been added to cars equipped with an automatic transmission. The combination of the new, lower splash shield assembly and the new side splash shield protects the converter air cooling system opening in the housing and also the torque converter drain hole in the converter housing. These

splash shields minimize entry of dirt and moisture into the converter housing thereby protecting the starter Bendix Drive against sticking. These splash shields entered production effective with Engine Nos. S-89465 and V-448068. Also, these splash shields entered production effective with car serial numbers S9S-81022 and 59V-30608; however, some cars after these serial numbers may not be equipped with the splash shields due to previously built-up engines in the engine stock bank.

- 1) Remove the two bottom engine rear plate-to-converter housing cap screws (identified by "A" in Fig. 6). Remove the engine rear plate cover and clip assembly and discard.
- 2) Remove the two engine rear plate-to-converter housing screws identified by "B" in Fig. 6. Install Part No. 1549244, Side Splash Shield, and reinstall the cap screws. This shield should be installed between the exhaust pipe support bracket and the engine rear plate.
- 3) Install the Lower Splash Shield and Plate Cover Assembly, Part No. 1549282 and secure with the cap screw identified by "A".

- 1) Remove the nuts (identified by "D") from the plate-to-converter housing bolts. Install the Side Splash Shield, Part No. 1549244, between

2) Remove the nuts identified by "C" from the bottom torque converter housing-to-plate bolts. Install the Lower Splash Shield, Part No. 1549243, on the bolts and reinstall the nuts.

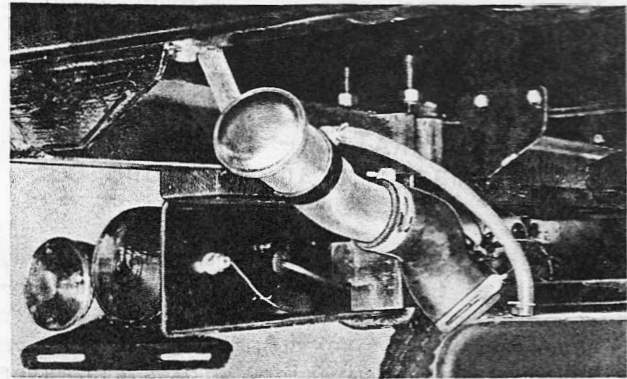
FIG. 7

It has come to our attention that when a stake or platform body is installed on a 4-wheel drive truck after production some difficulty may be experienced in filling the gasoline tank.

This difficulty can be corrected by modifying the gasoline tank filler neck as shown in Fig. 7.
