# Service Bulletin

JANUARY

1961

NO. 359

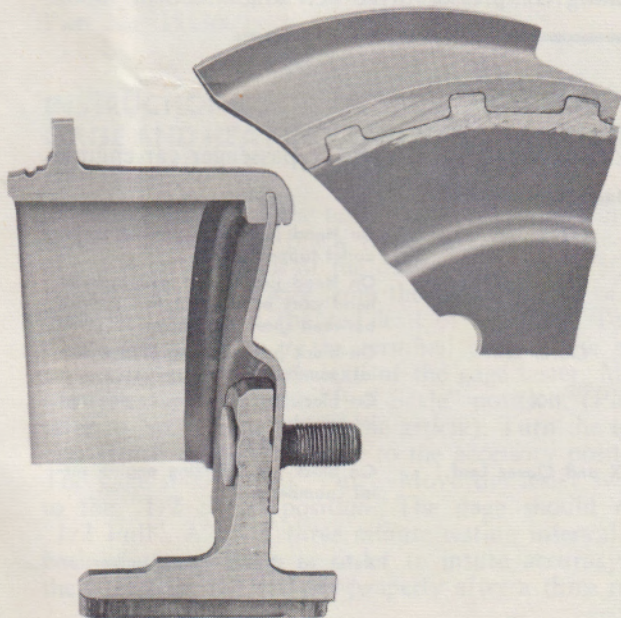
Fig. 1

Several hub and drum assemblies have been returned to the factory by dealers with the complaint of being cracked. In nearly every instance, our inspection of the returned assemblies shows no evidence of a crack or fabrication defect.

The brake drum is of a two-piece construction as shown in Figure 1. The brake drum proper is of cast material, while the supporting web is stamped steel. The stamped steel web is locked into the drum by Keystone shaped tangs. The drum assembly is fabricated

by casting the drum around the tangs and outer diameter of the steel supporting web.

In this type construction, there may be visible separations between the drum and the web which may appear to be cracks. This condition is normal and hub and drum assemblies should not be replaced for this reason alone. However, if inspection of the drum shows that the supporting web is actually loose in the drum, the hub and drum assembly should be replaced.

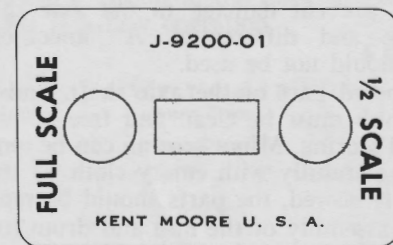
FIG. 2

NOTE—Due to a manufacturing error, the switch positions on the early production J-9200 Testing Units were incorrectly labeled. The Full Scale and the 1/2 Scale positions on the face of the gage were reversed.

The error was corrected in production. The corrected test units are identified with the number J-9200-01 and operate as indicated on the face of the unit. Figure 2 shows a J-9200-01 decal that can readily be applied to the J-9200 Test Unit. If your test unit is identified as a J-9200, notify the Technical Section, Parts & Service Division, and the correct decal will be sent to you at no charge.

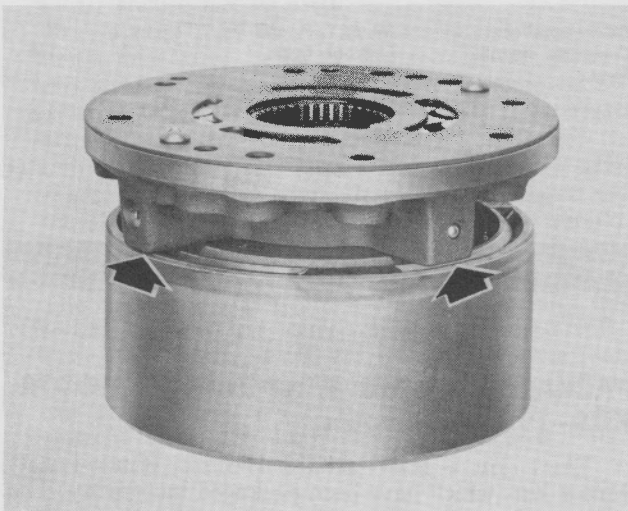
FIG. 5

To insure against interference between the welds on the back of the high range clutch housing and the ribs on the front pump when installing a new housing, check the clearances prior to installation as follows:

Contact of high weld points on the clutch housing of the pump rib produces a clicking noise when engine torque is applied in low or reverse.

Place the correct thrust washer, or thrust bearing combination on the front pump hub for the model involved and install the clutch housing on the pump hub. With a feeler gauge, check the clearance of the three welds to the pump ribs, Fig. 5, by rotating the housing. The clearance should not be less than .050" minimum for any of the welds. If any of the welds have a clearance less than the minimum stated, grind off the high spots only of the weld or welds involved. Remove only the necessary amount of weld required to produce a minimum clearance at the welds.

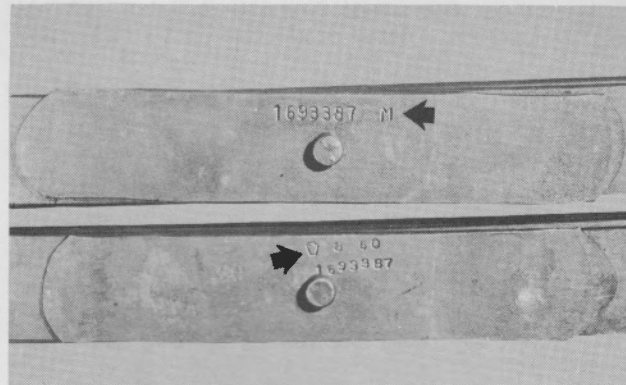
FIG. 6

In the beginning of 1961 truck production the front spring assembly for the 6E5 and 6E10 Heavy Duty and the 6E7 and 6E12 standard spring, Part No. 1693387, was supplied by two vendors. One used the letter 'M' for identification, the other a Keystone symbol. The identification mark is located on the short leaf adjacent to the spring center bolt. (See Fig. 6.)

The spring with the Keystone symbol has a considerable difference in carrying height than the assembly identified by the letter 'M'. It will be necessary on trucks with serial numbers prior to 6E5-130412 and 6E10-39031 to determine the identity of the vendor before ordering a spring assembly or the components thereof.

To service the Front Spring, Part No. 1693387, on trucks with serial numbers prior to those listed above and having the Keystone symbol, order Front Spring Assembly, Part No. 682829, or its respective leaves as listed in the Parts Catalog.

To service the front springs bearing the letter 'M' identification mark, order the Spring Assembly, Part No. 1693387, or its respective leaves as follows:

To service Front Spring Assembly, Part No. 1693388, with the Keystone symbol, order Spring Assembly, Part No. 682830, or its respective leaves as listed in the Parts Catalog.
