Service Bulletin

NO. 340

Studebaker and Packard

SPEEDOMETER CORRECTIVE SERVICE

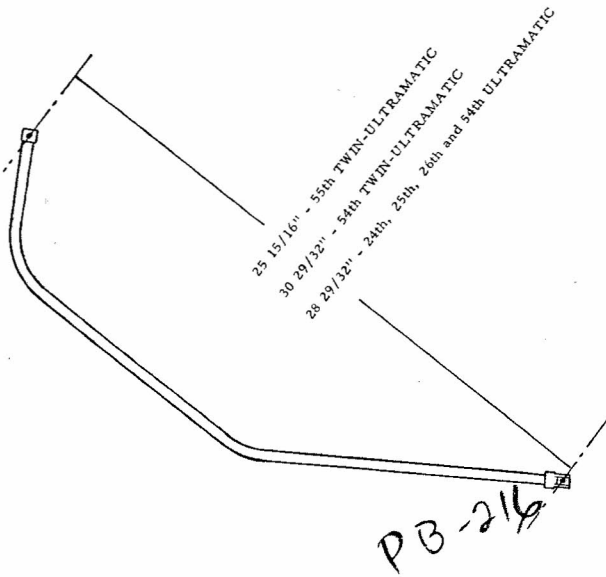
Fig. 6

Because of the shape of this rod, it is difficult to determine if it is bent. Its function is to control throttle pressures, clutch engagements and upshifts. Therefore, it is very important that the rod is of proper length. Figure 6 shows the manner in which the rod should be checked and the proper lengths for the various models.
