# Service Bulletin

JANUARY

1961

NO. 359

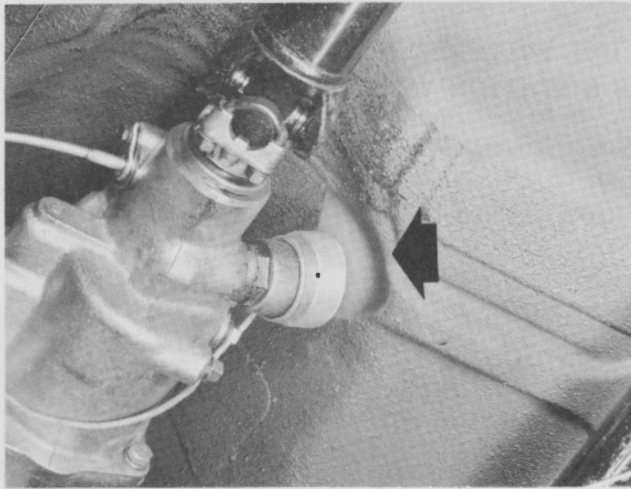
FIG. 7

**REMOVAL OF OVERDRIVE GOVERNOR—  
Models 6E5, 6E7, 6E10 and 6E12**

In some instances the overdrive governor may interfere with the floor pan when attempting to remove the governor from the transmission. In such cases a ready remedy to the problem is to take a caulking iron and relieve the floor pan in the area adjacent to the governor. Figure 7 shows the area to be relieved. A similar correction is being made in production beginning with Serial Nos. 6E5-130484, 6E7-14460, 6E10-39034 and 6E12-4758.
